VOLUME 31 • NUMBER 1 • SUMMER 2004

Overview of some Corvette (mid-year) door anatomy

Dave Zuberer, 2004

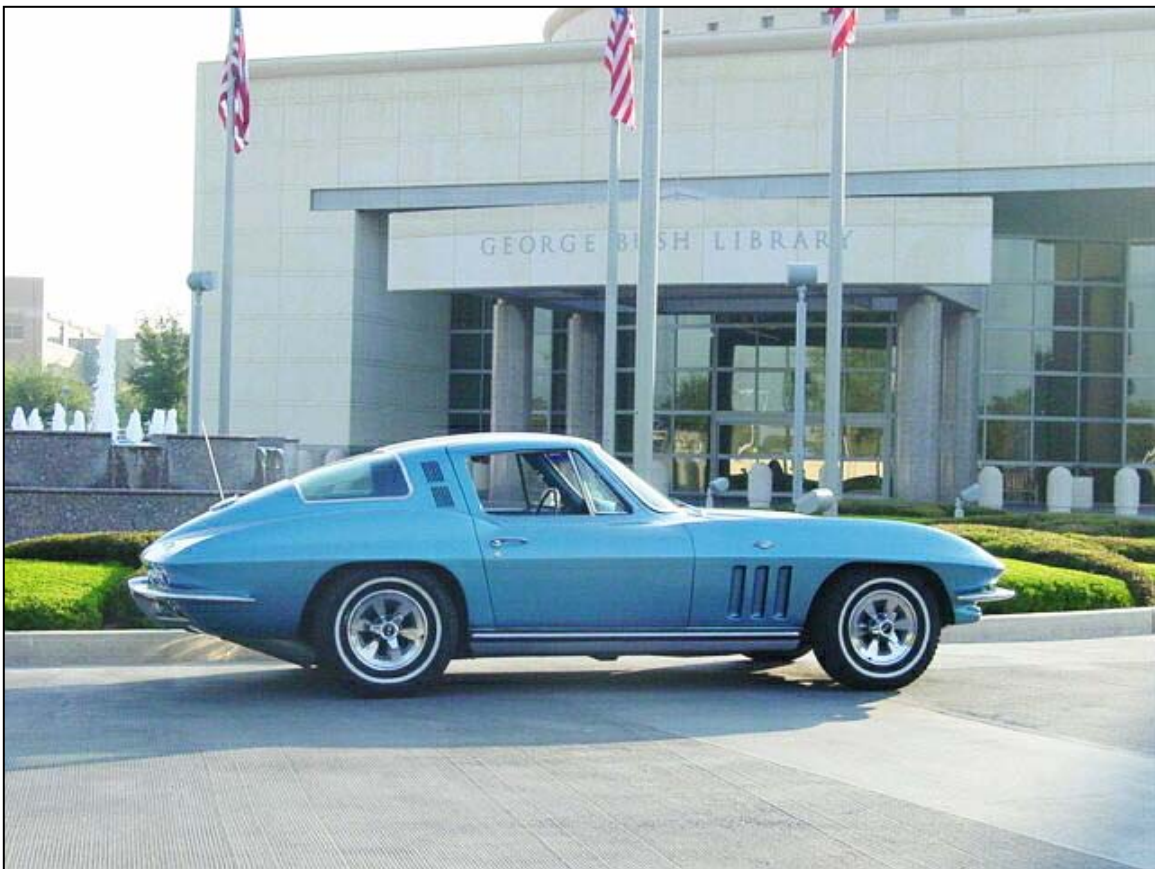
Figure 1: Overview of coupe door

An overview of the 1965 coupe door is shown in **Figure 1 A and B**. Figure 1A shows the complete door panel and locates various components that must be removed in order to remove the panel from the door. Figure 1B shows the door with the door panel removed and illustrates positions of various components.

Once the door panel is removed, remove the large access panel toward the rear of the door (Figure 1B). There are 3 screws and the panel is tucked into the door at the bottom of the access hole. If you are going to remove the Vent Window Regulator (see Figure 5, lower panels) remove the forward access panel, remove the 3 screws holding the regulator to the bracket, remove the 3 hex head bolts holding the bracket to the door and remove the Hex bolt that holds the T-post of the vent window in the regulator pivoting gear. Regulator should slide off the T-post. Check back plate of the regulators for looseness. This is a source of play in the cranking mechanism (Figures 5 and 6).

With the side window out, removal of the vent-window assembly (Fig. 10) is much easier. Remove the nut from the stud at the bottom front of the door (Figure 1B and Figure 10) and carefully push the stud back into the door pocket. Remove the screw holding the assembly at the top of the door (just below the vent window (Figure 1B).

The installation is essentially the reverse of the steps above. After you have made any repairs / restorations of the vent window assembly, window channel liner, etc., place the vent assembly back in the door pocket and guide the lower stud back through the hole in the bottom of the door (Fig. 1B). (You can remove the stud during this operation if need be. You can reach in through the access panel to reattach the stud). You can leave the vent assembly loose at this point so long as it fits snug against the front of the upper frame. The window channel liner (one-piece upper and lower rear) should have been replaced earlier. Leave upper front bubble clips detached so you can get the vent assembly into place (see Figure 7). It will be helpful to slightly squeeze the two bubble clips that go into the rear lower window channel (still unattached at this point). It makes them easier to insert into or and remove from the channel if need be (Fig. 7 lower right).

If everything works, you can replace the screws (4) in the vent window frame (Fig.11). Replace the large screw securing the vent window channel to the door (Fig. 1B). Replace nut on lower stud and adjust in or out as necessary (Fig. 1B and Fig. 10)

These studs mount to the upper roller track with hex nuts with captured star washers. The nuts are accessible when the window is positioned so that you can see them through the holes in the fiberglass door panel (Figure 1B)

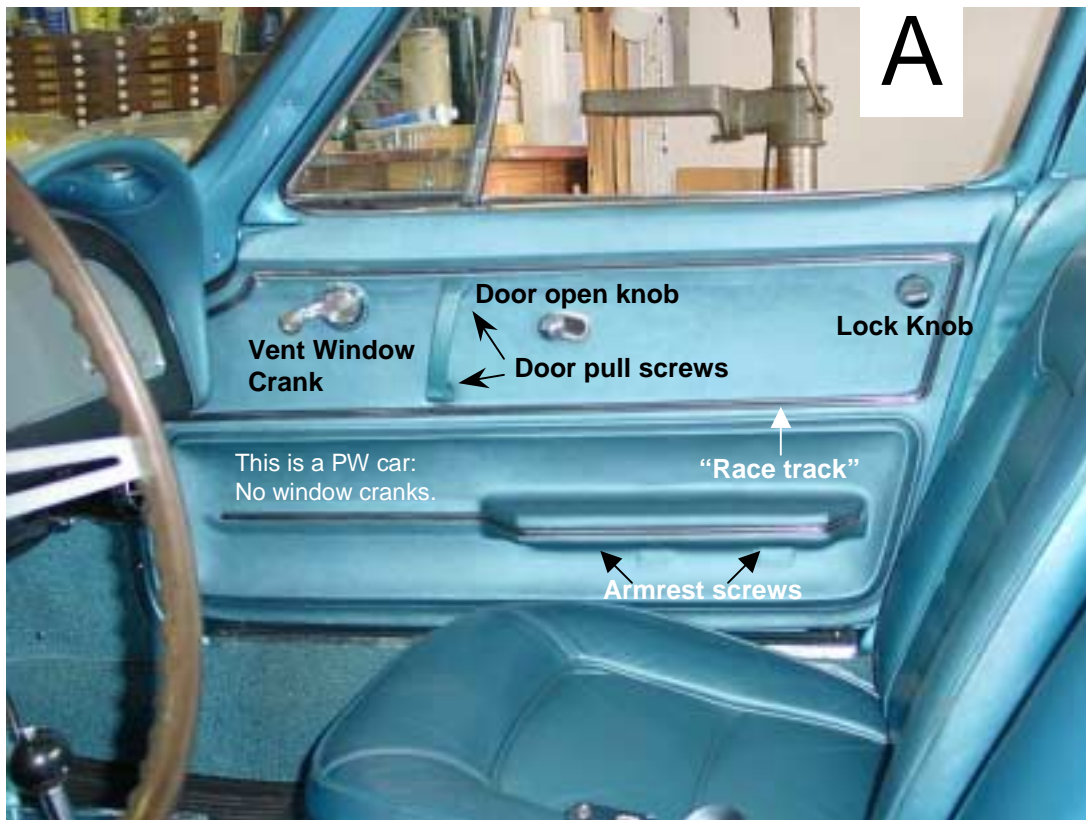
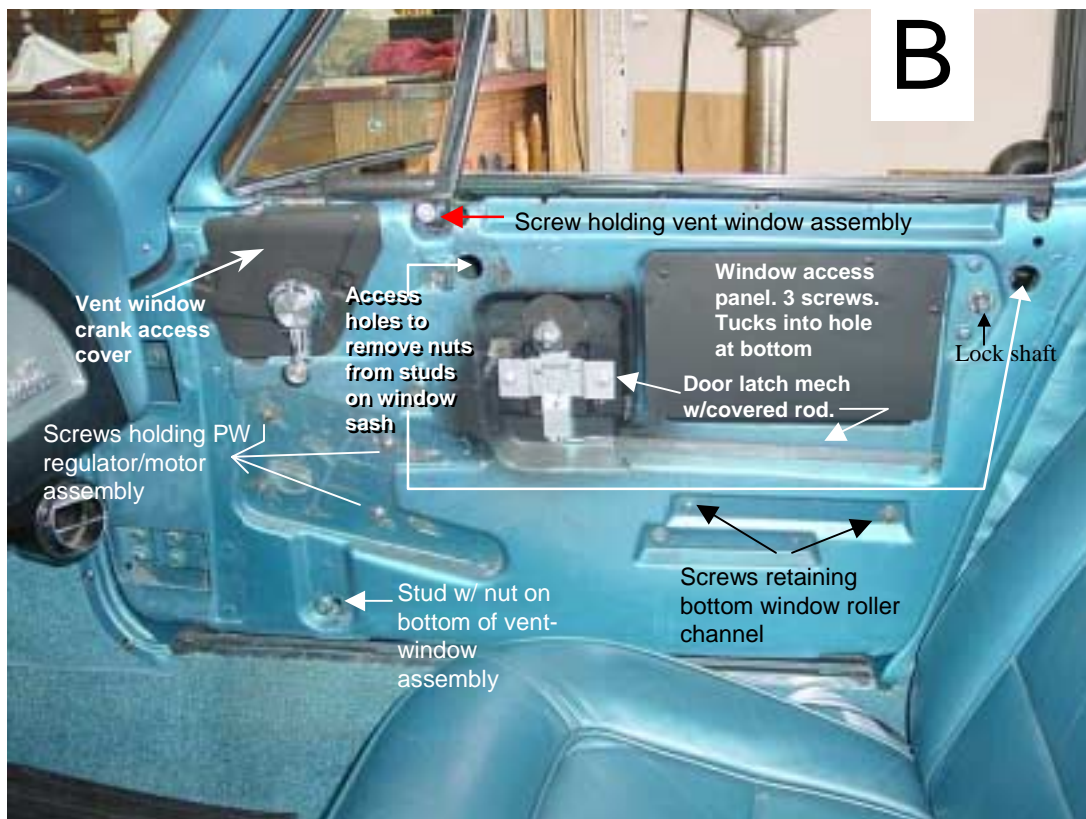
Note: This is a power window car so no window crank is shown.

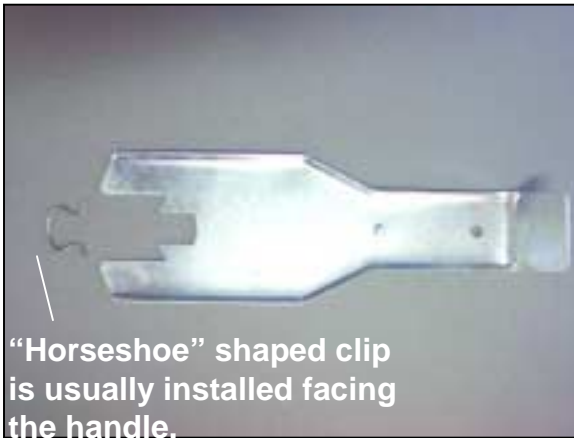
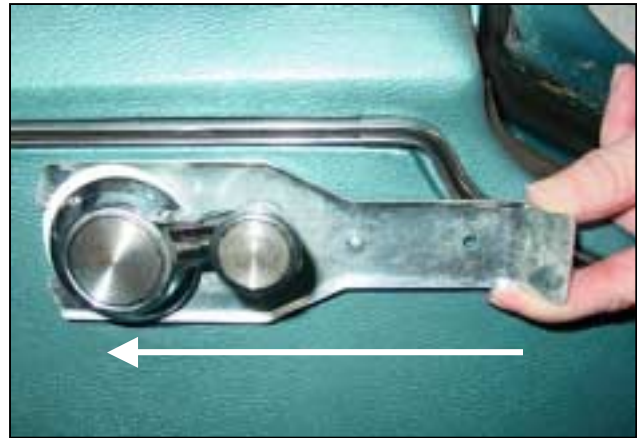
Figure 2: Crank and lock clip removal

Tool for removing window handle/lock retainer clips.

Clip is usually removed in this direction

- Remove window crank handles using the clip removal tool (**Figure 2**; available at most auto-parts stores, Sears, etc.). Clips are usually installed with the open end toward the handle. . If you have standard windows, remove the crank as you would for the vent window crank handle.
- Remove the lock knob using the same tool
- Unscrew the door opener knob from the shaft.
- Remove the two screws from the top and bottom of the door pull
- Remove the two large screws from under the armrest.
- Remove the 5 door-panel clips (**Figure 3**). At this point you should be able to pull out the bottom of the panel and raise it from the top support of the door.

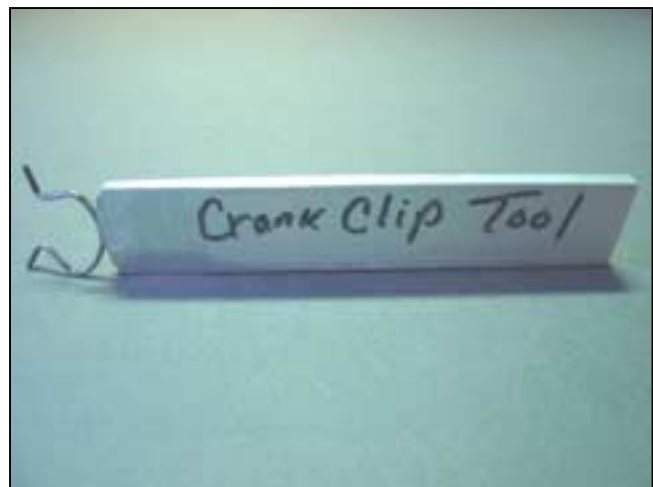
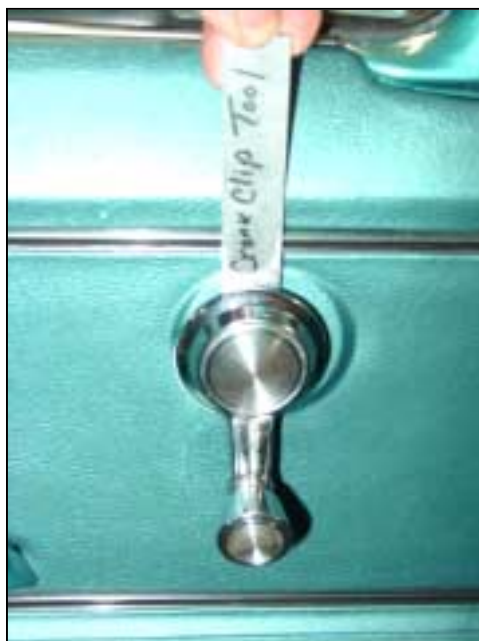
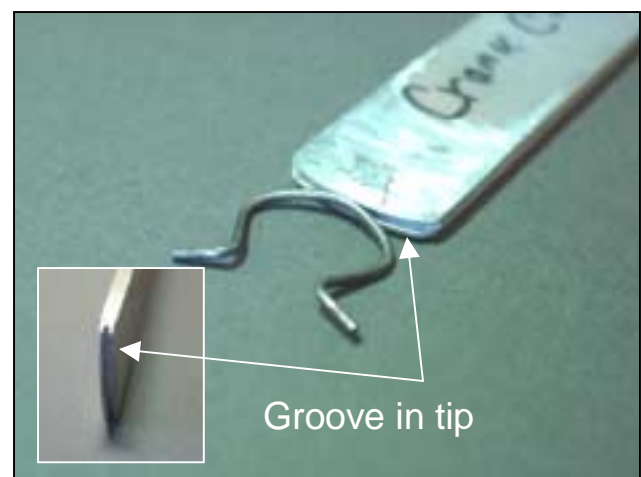
Clip-Install Aid: Here is a tool that I made to assist in installing the horseshoe clips. It's made from 1/8th by 3/4" aluminum bar tapered by sanding both sides. The groove was cut in with a hacksaw. We "pre-staged" the clip onto the window crank and with the tool engaged as seen at lower right, slid the handle onto the shaft and pushed the clip into place.

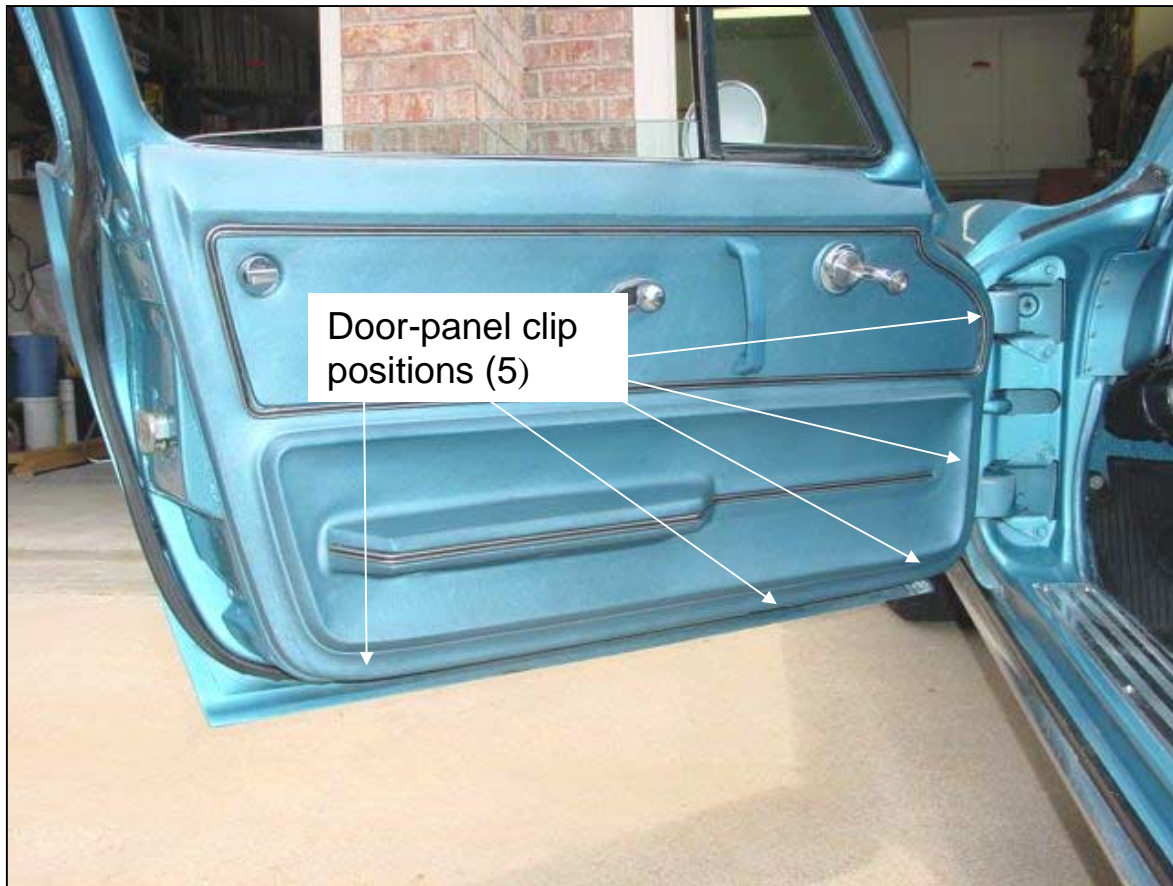
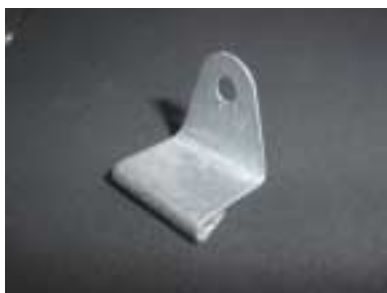
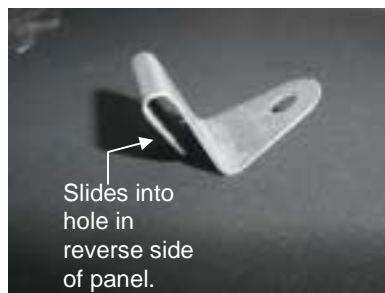
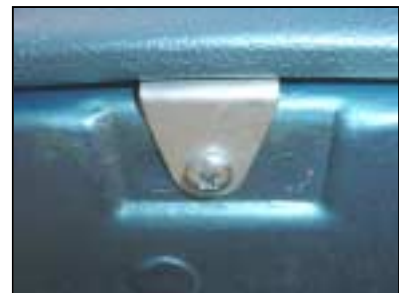
Figure 3: Door-panel clips: removal and installation

Installed panel clip

Door panel clips. These clips slide into the rectangular holes on the back of the door panel. We made some “butterfly” reinforcements out of the metal strapping you can find at any lumber yard. The reinforcement is slid between the foam and the pressed cardboard of the panel and centered by pulling on the small hole with an awl (see next figure). We only had to remove one staple on one panel. This could vary.

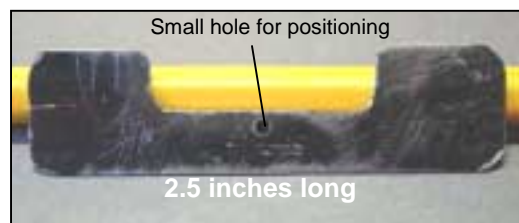
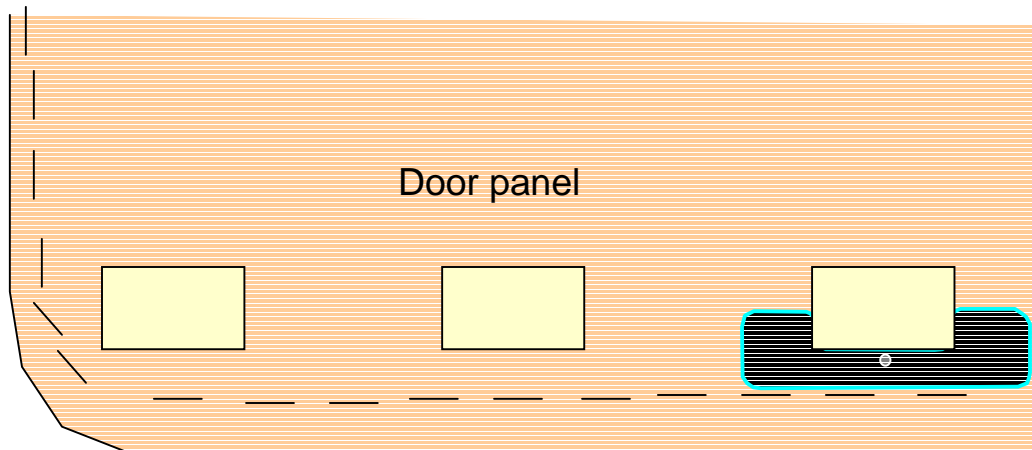
Figure 4: Door-panel clips con't.

“Butterfly” reinforcement for door-panel clip holes.

Inserting :”butterfly” reinforcements.

Slide metal between foam and board

Push in until metal fits inside of hole.

Push right side down between board and foam and slide to center using the hole and awl.

Slide metal back to center and then down so that it cannot be seen

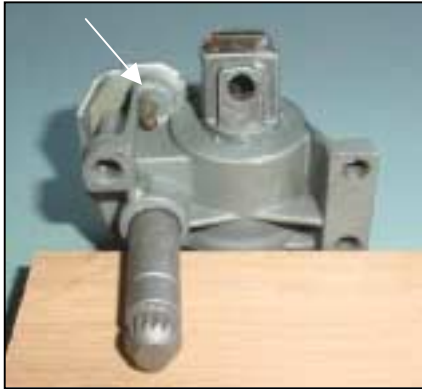
Figure 5: Vent-Window regulators

“Front” view of vent-window regulator

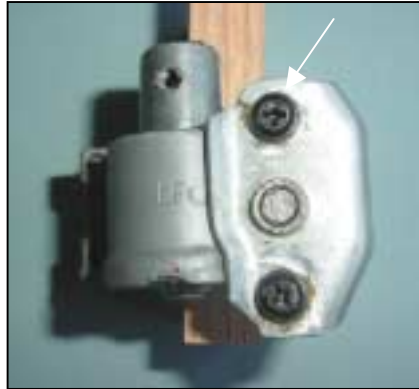
Repaired regulator
Note screws (arrows)

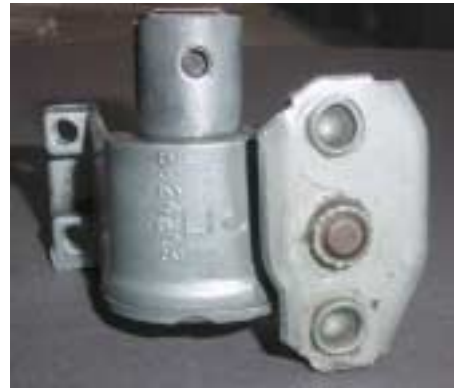
Regulator showing the normal “peened” pot-metal studs holding the backing plate.

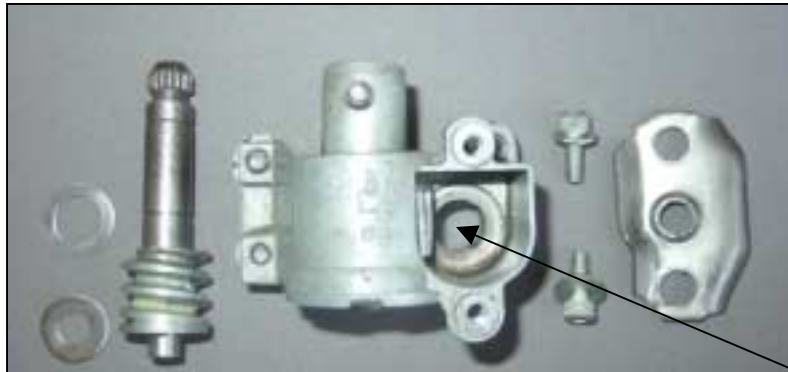
Components of a vent-window regulator

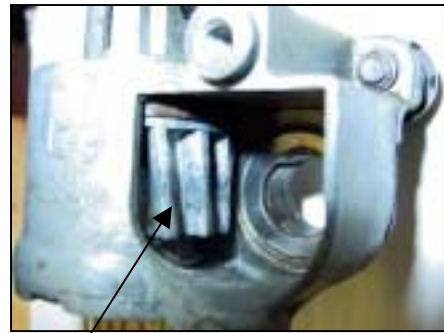
Large pot metal pivot gear.
Prone to stripping if forced.

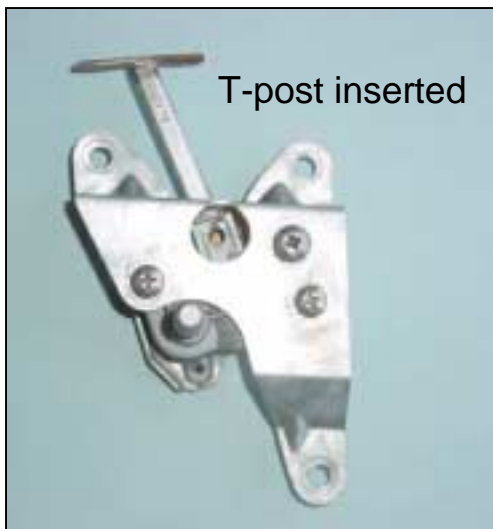
T-post inserted

Vent-window regulator attached to bracket that attaches it to the door. T-post from vent window shown for reference.

Replace vent window regulator on T post. Replace regulator-mounting bracket with the 3 screws removed earlier (Fig. 5 bottom panels).

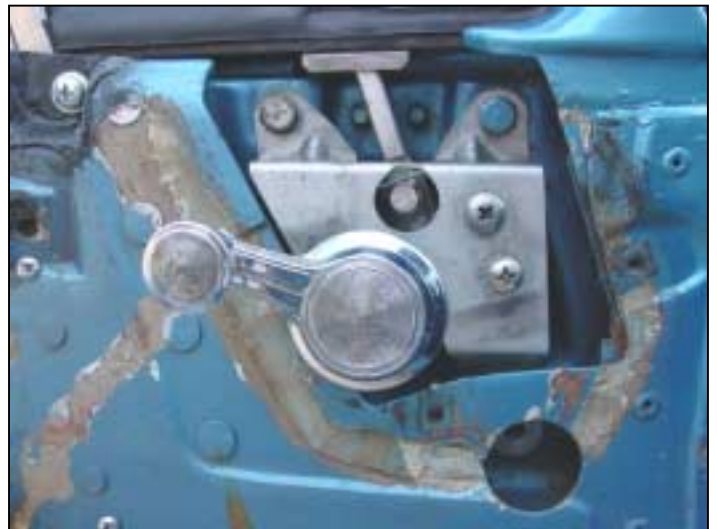
Vent-window regulator installed in door

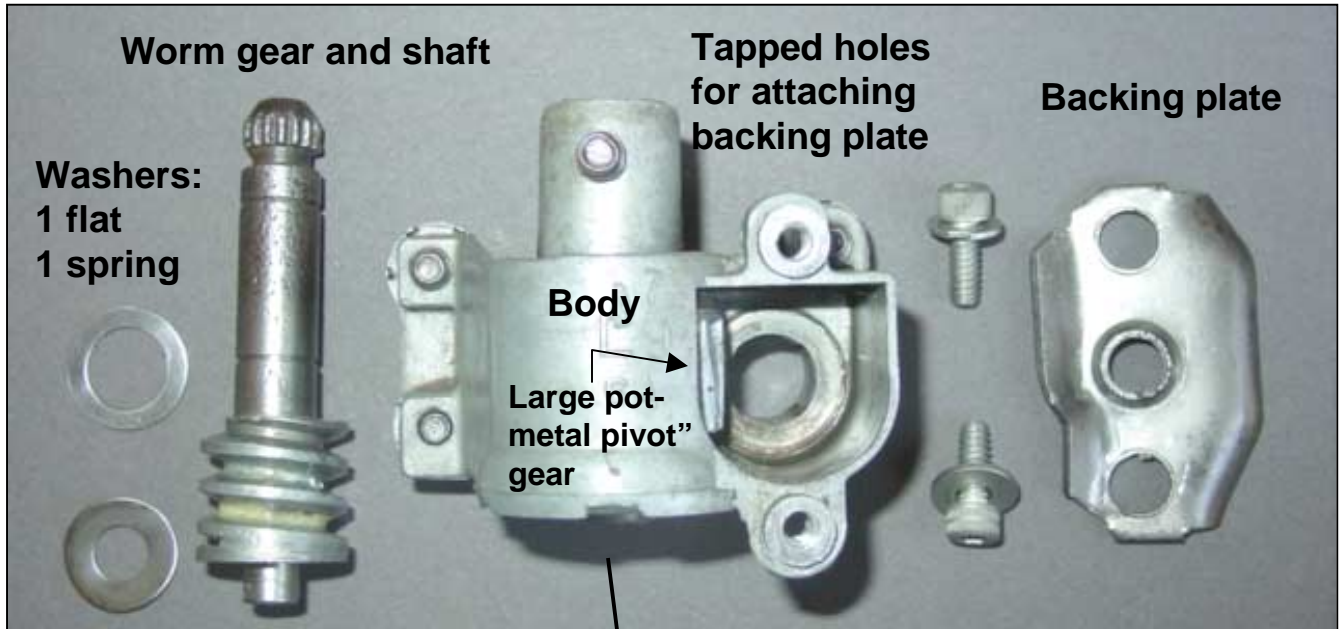
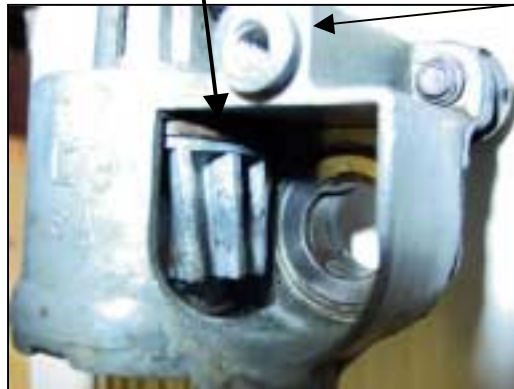
Figure 6: Components of a vent-window regulator:

Peened pot metal ground to be flush with surface of backing plate and drilled to accept screws to attach the plate as below.

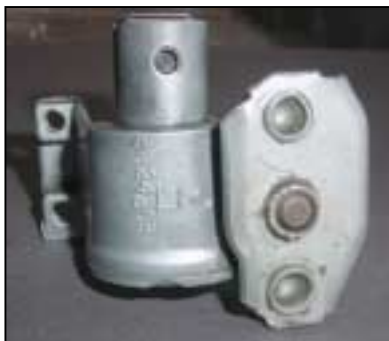
Normal regulator

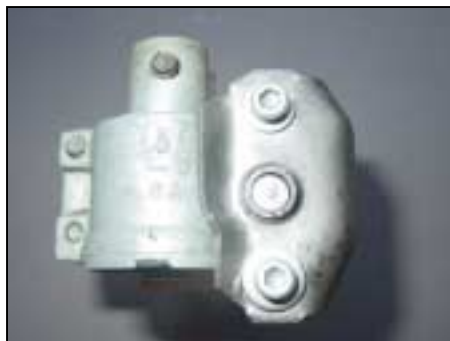
Repaired regulator

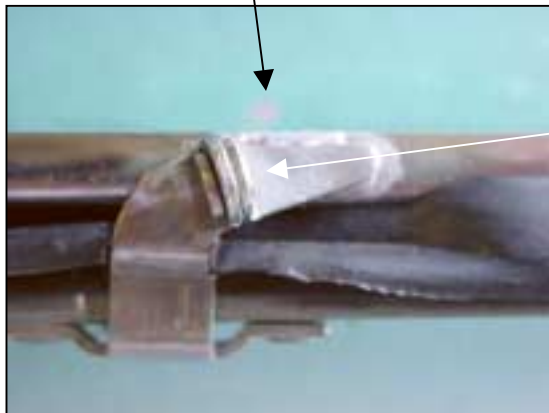
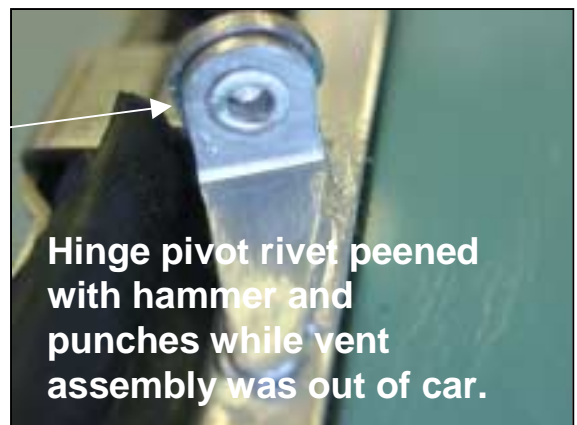
This is a vent window pivot hinge that has been replaced earlier. Note poor welding.

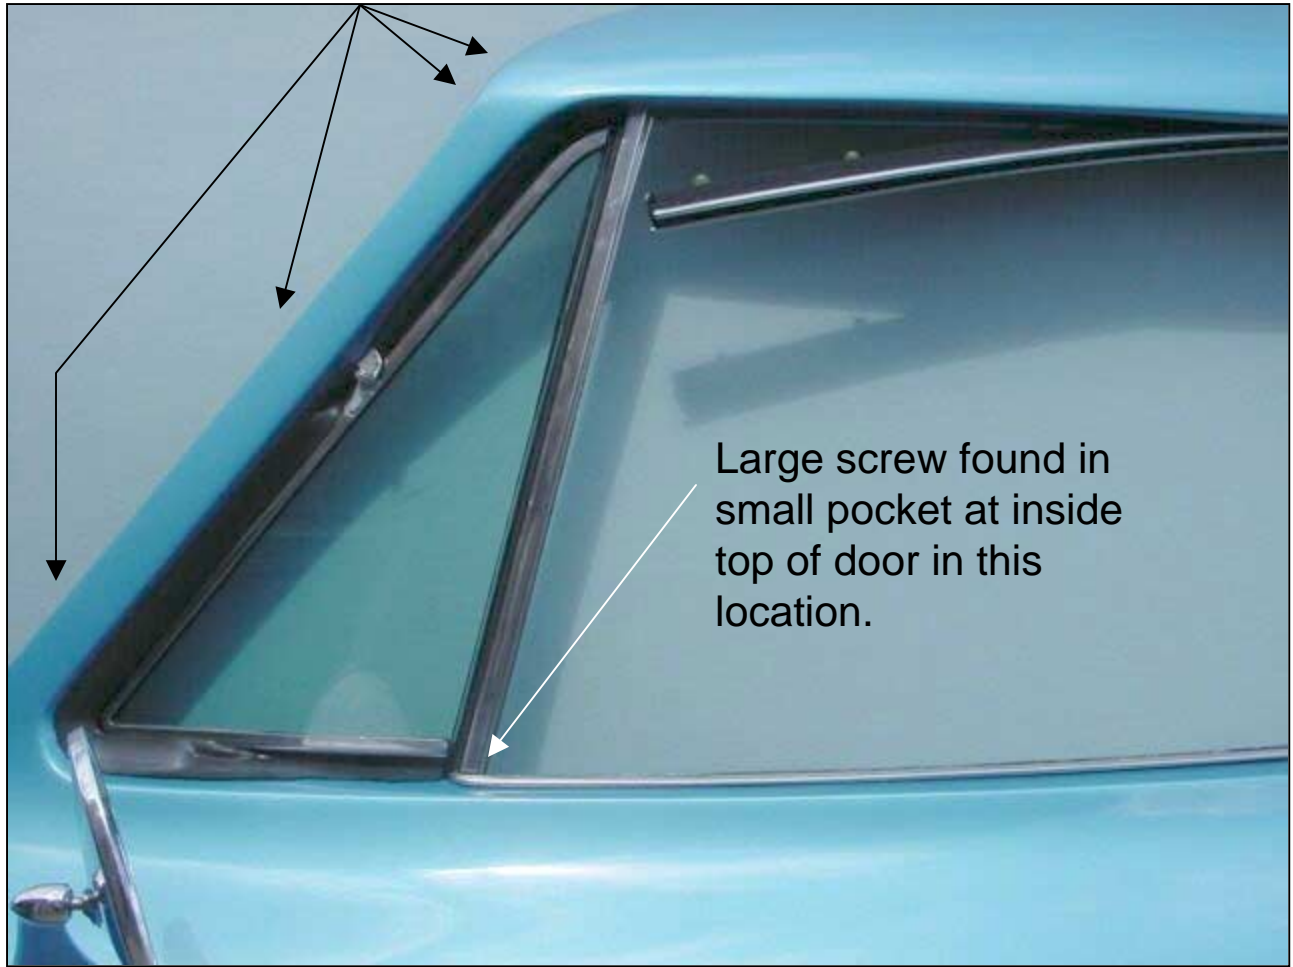
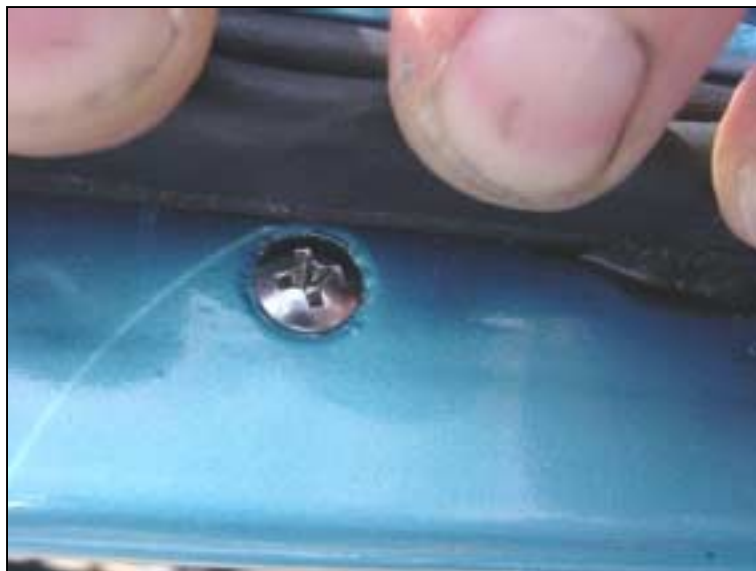
Figure 11: Vent window screw locations

Vent-window mounting screws (4)

Peel back door weather strip to reveal the 4 small screws retaining the vent-window assembly to the door frame.

Peel back the weather stripping along the leading edge of the door to reveal four small Phillips-head screws (two near the top curve, one in the middle and one near the bottom (Figure 11)). Remove these screws. With these screws removed, the lower stud pushed inside the door and the larger screw removed from near the top of the door, the assembly should move backward fairly easily and you can raise it out of the door taking care not to hang up the bottom stud as you bring it out. You need to have the window channel liner disengaged from the upper front of the doorframe (see Figure 7) so you can bring the vent assembly back. At this point, you may already have it out of the doorframe.
